BYERS PIPE

BULLETIN No. 30

An Investigation of Pipe Corrosion

Showing service records of iron, steel
and brass pipe used for hot and cold
water supply lines in 129 Pittsburgh
Apartment Buildings

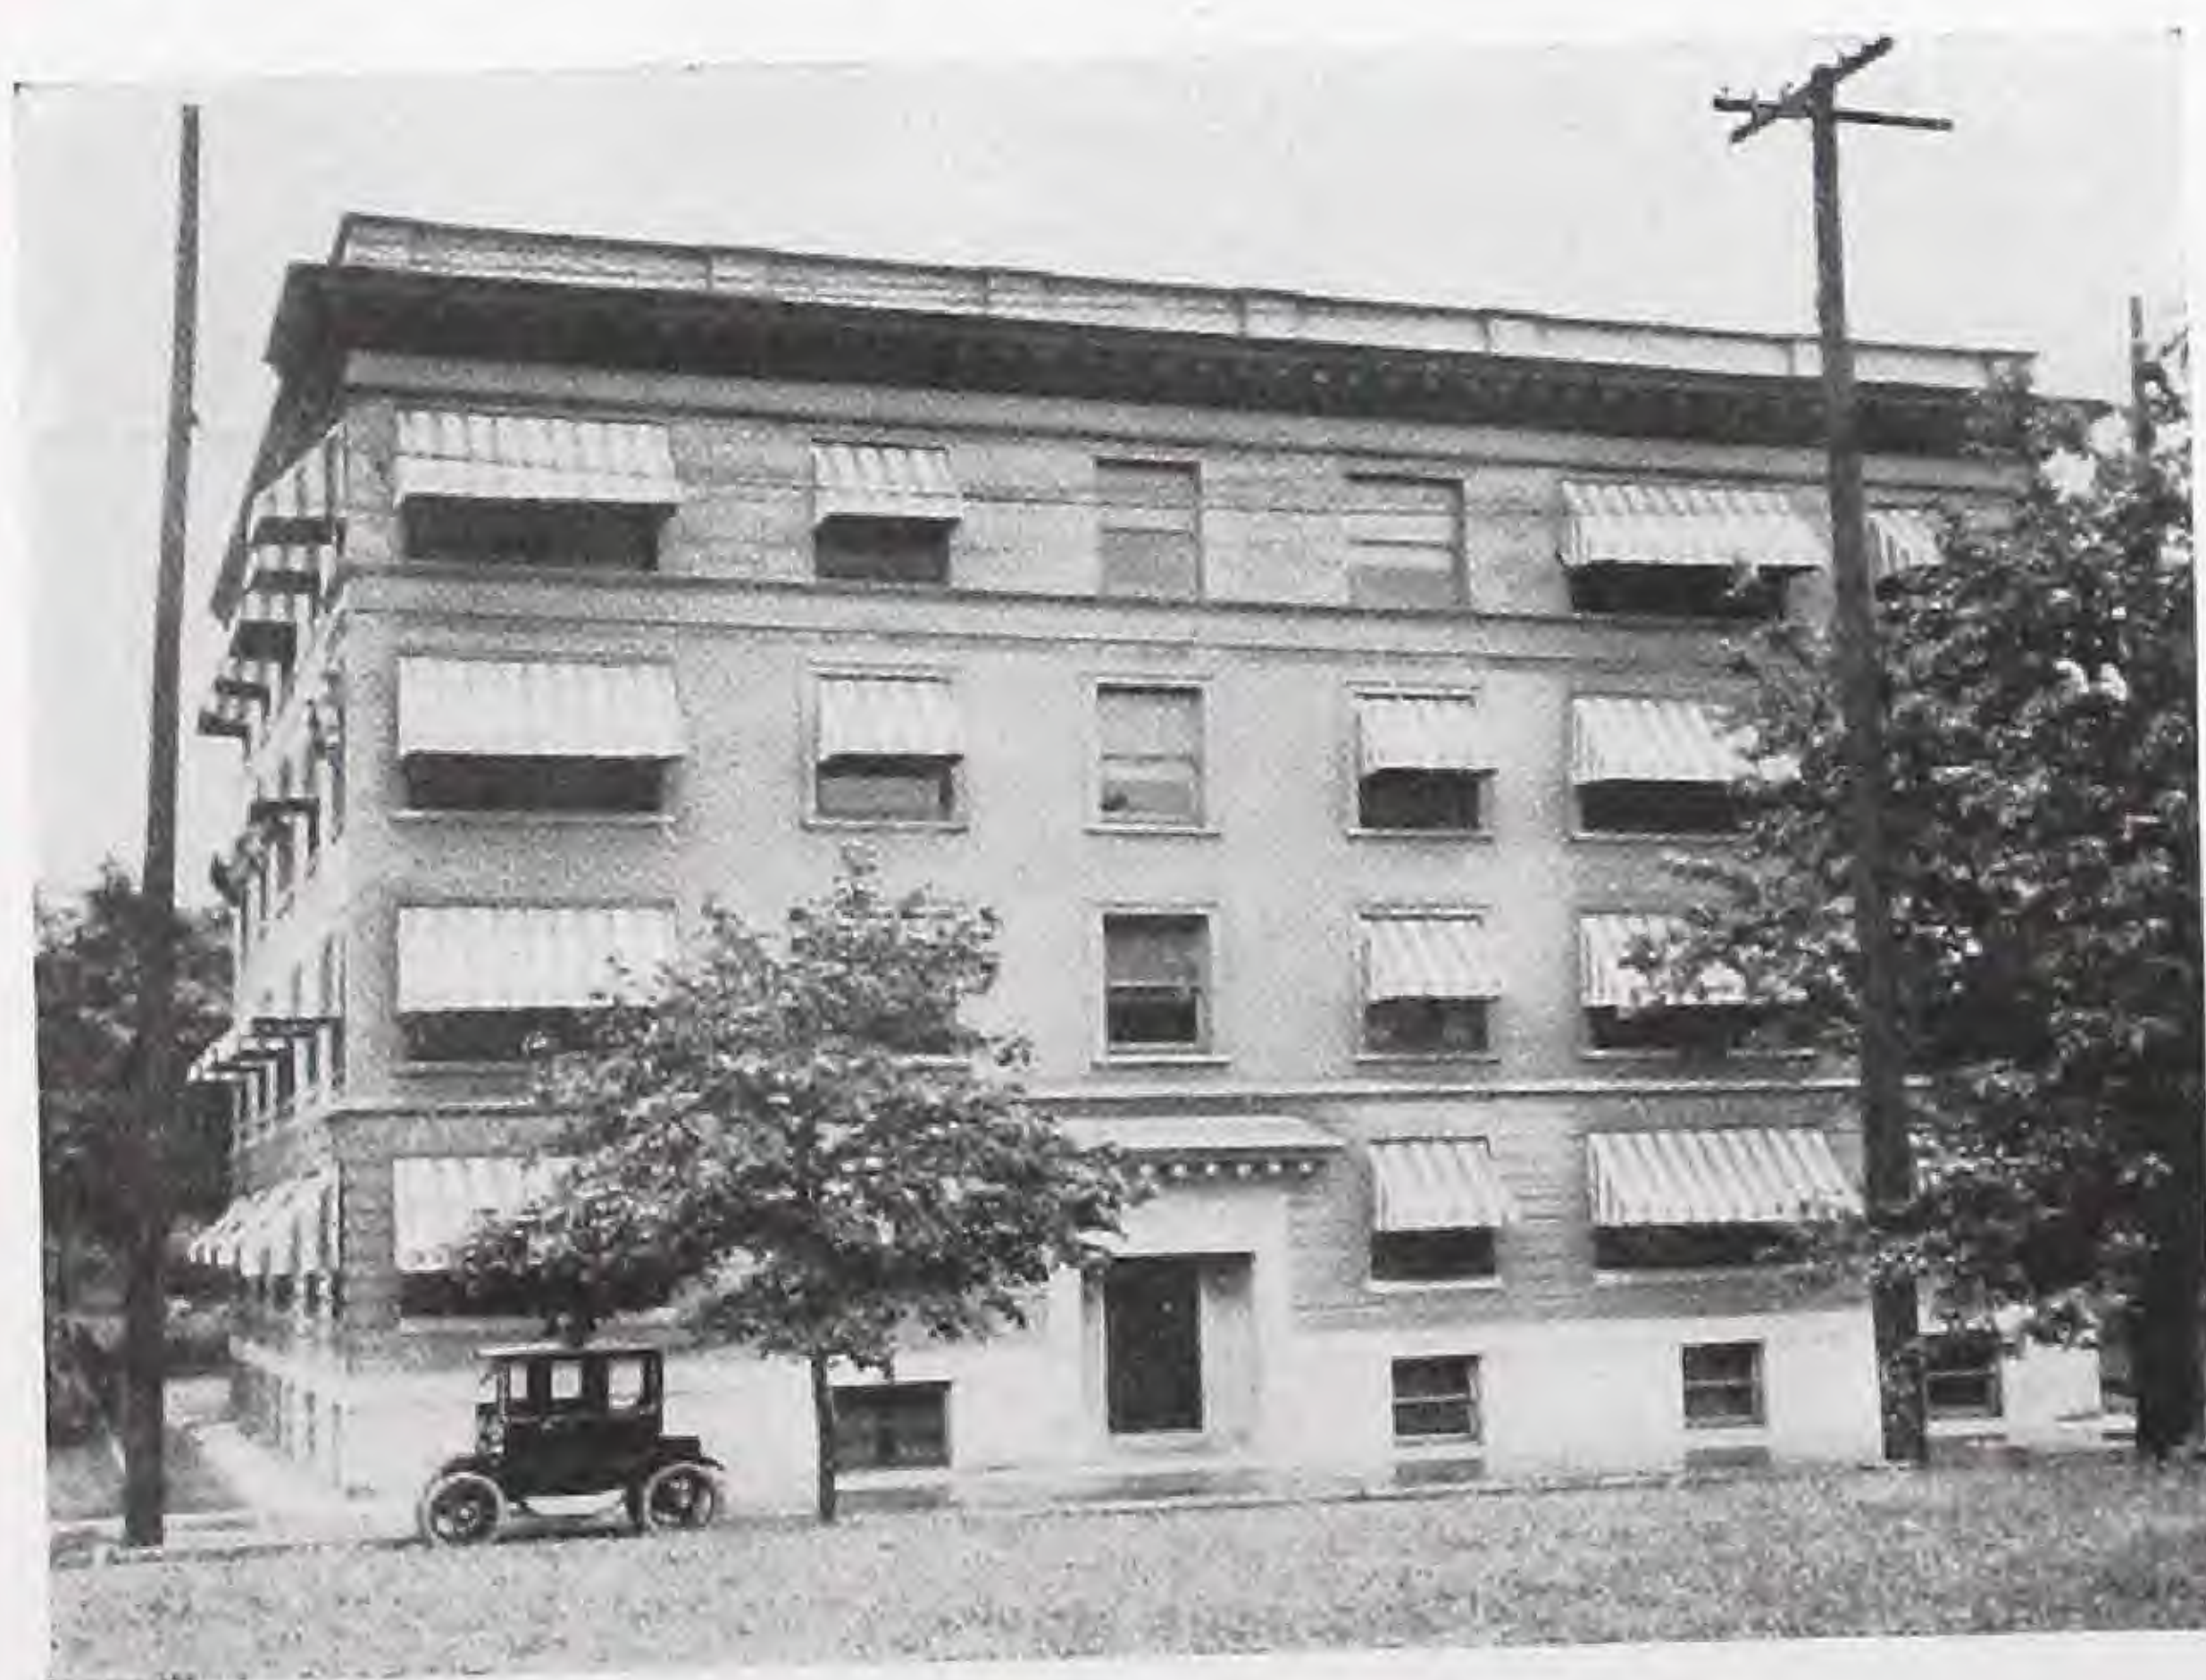
D'Arlington Apartments, erected 1909, equipped with brass pipe. The hot water lines are badly corroded and pitted after 8 years' service. Record No. 7, Brass Installations, page 17.

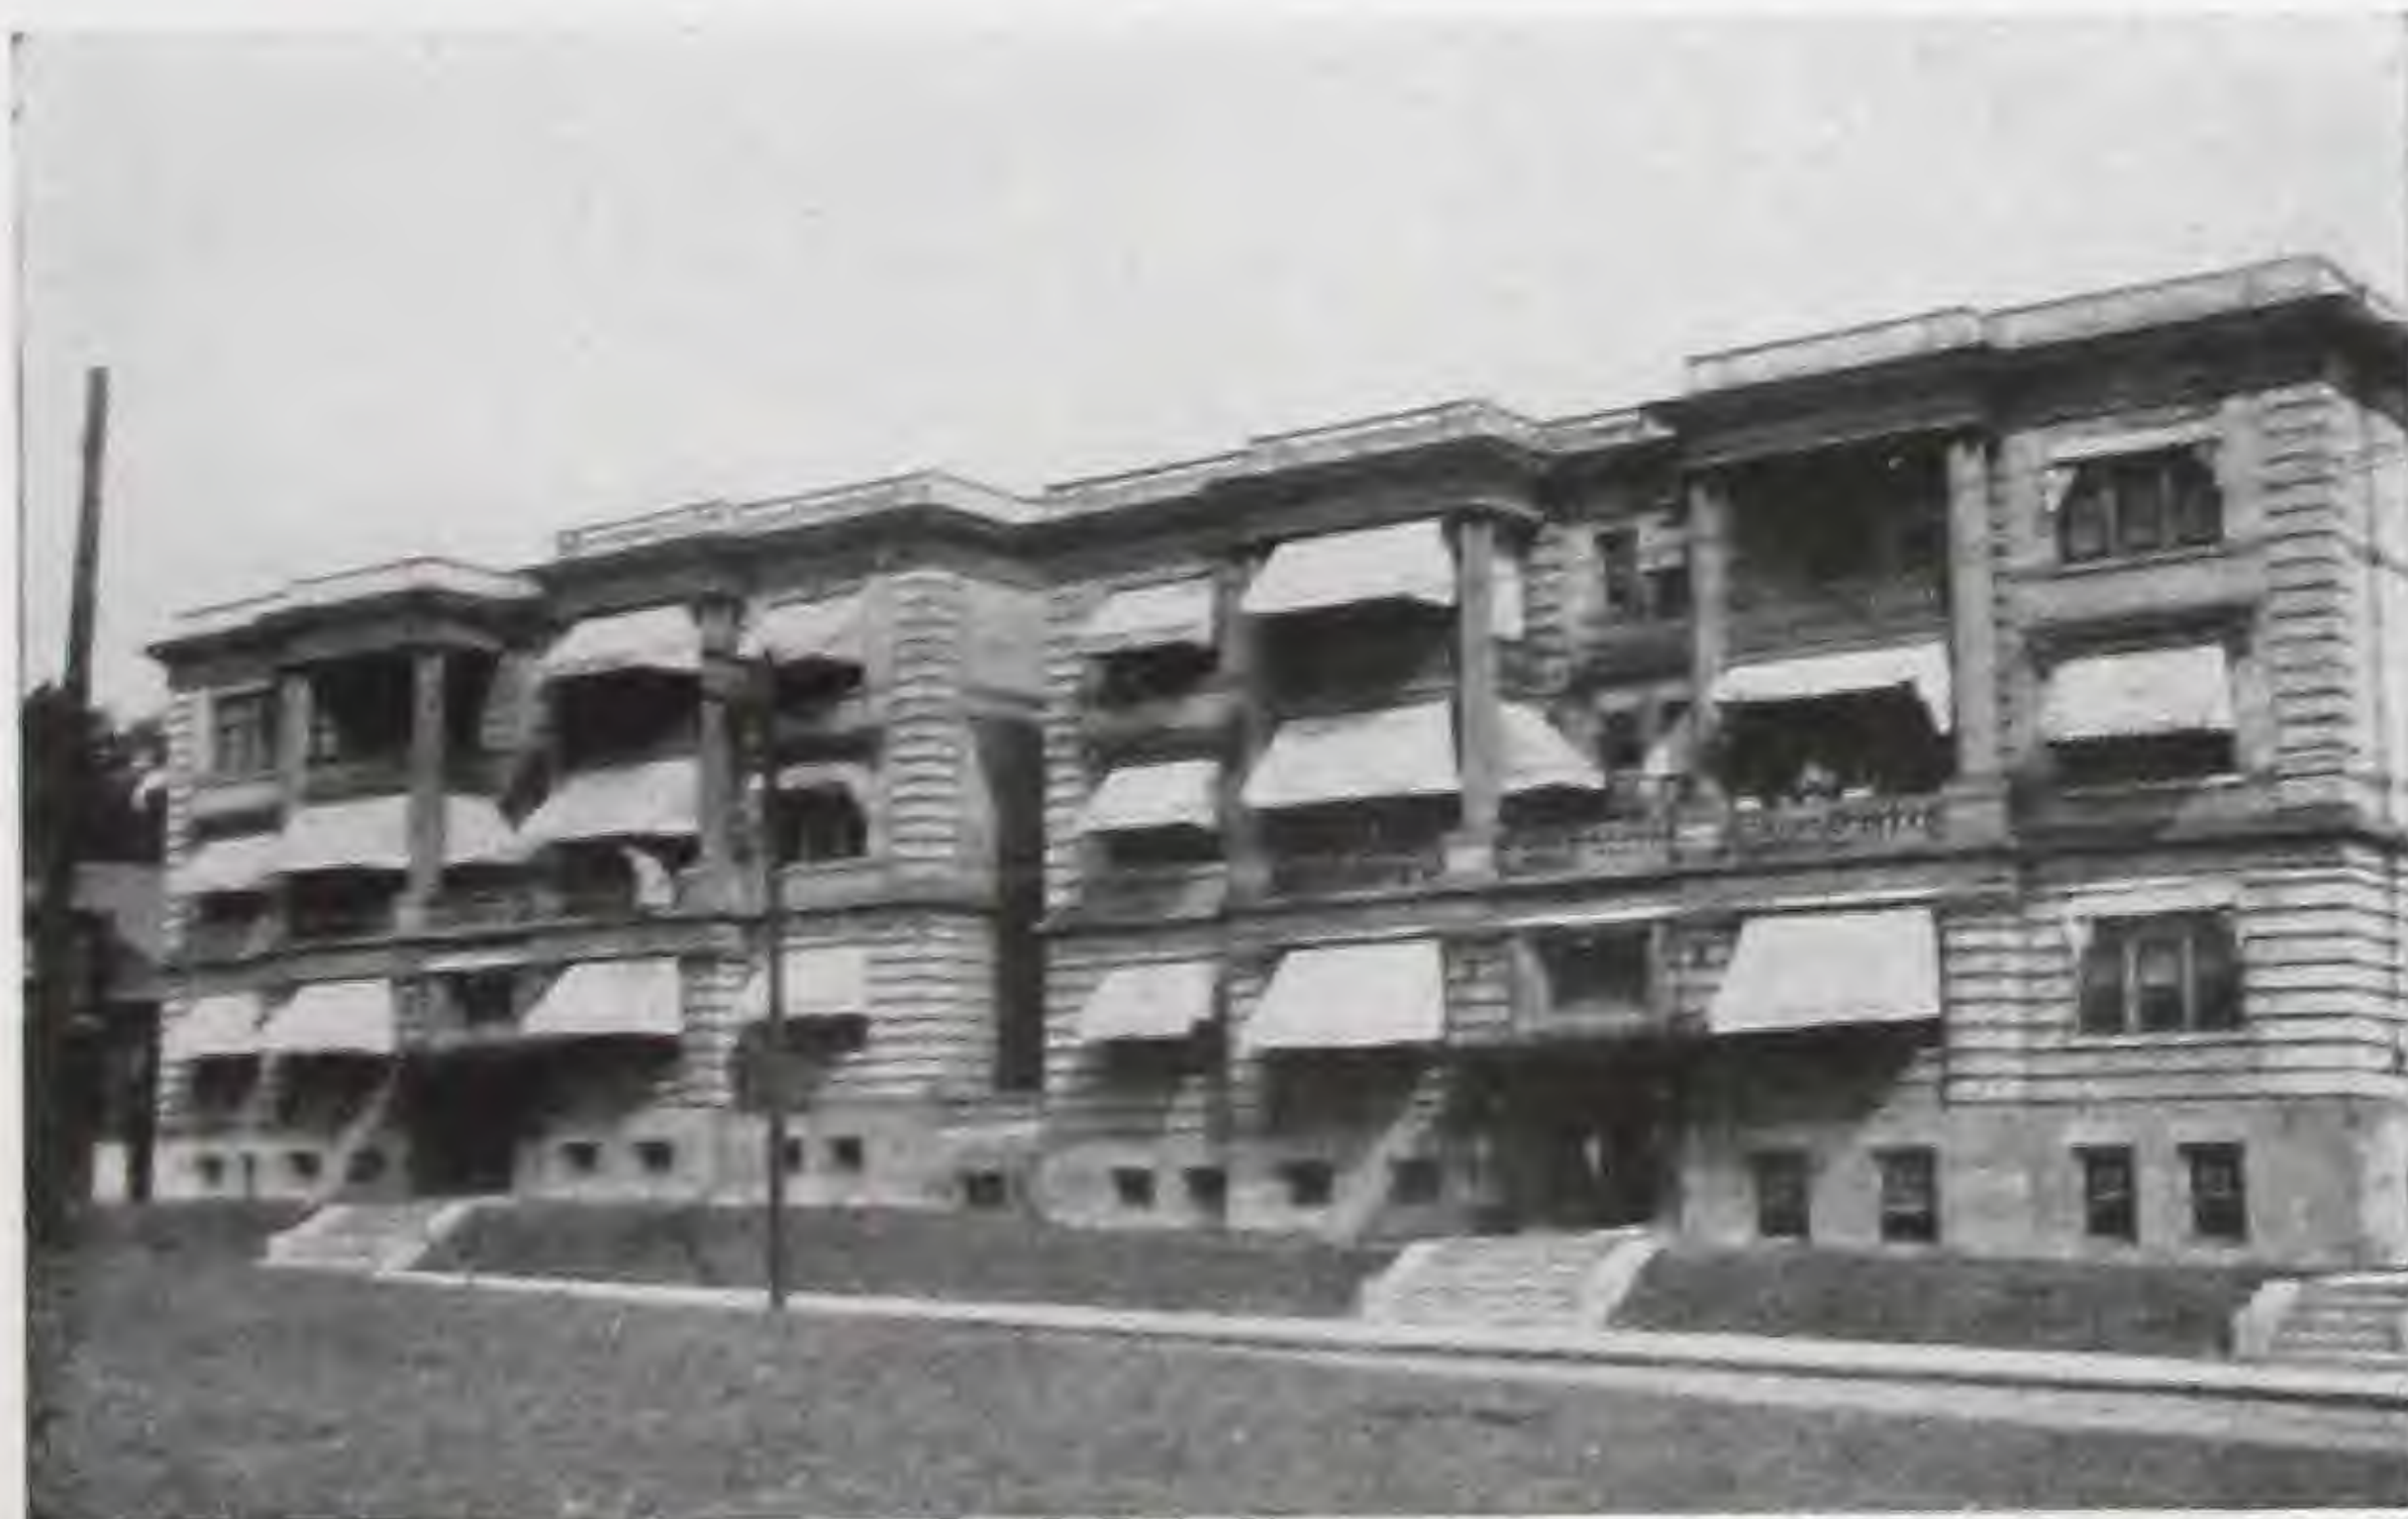
Lafayette and Cambridge Apartments, McKee Place, erected 1902, equipped with wrought iron pipe. Most of the hot water mains were replaced in 1917, after 14 years' service. Record No. 42, Wrought Iron Installations, page 16.

42. Lafayette and Cambridge Apts. McKee Place.	12	1902	Most of hot water mains in basement replaced 1917.	14 yrs.	14 yrs. Still good	14 yrs. Still good

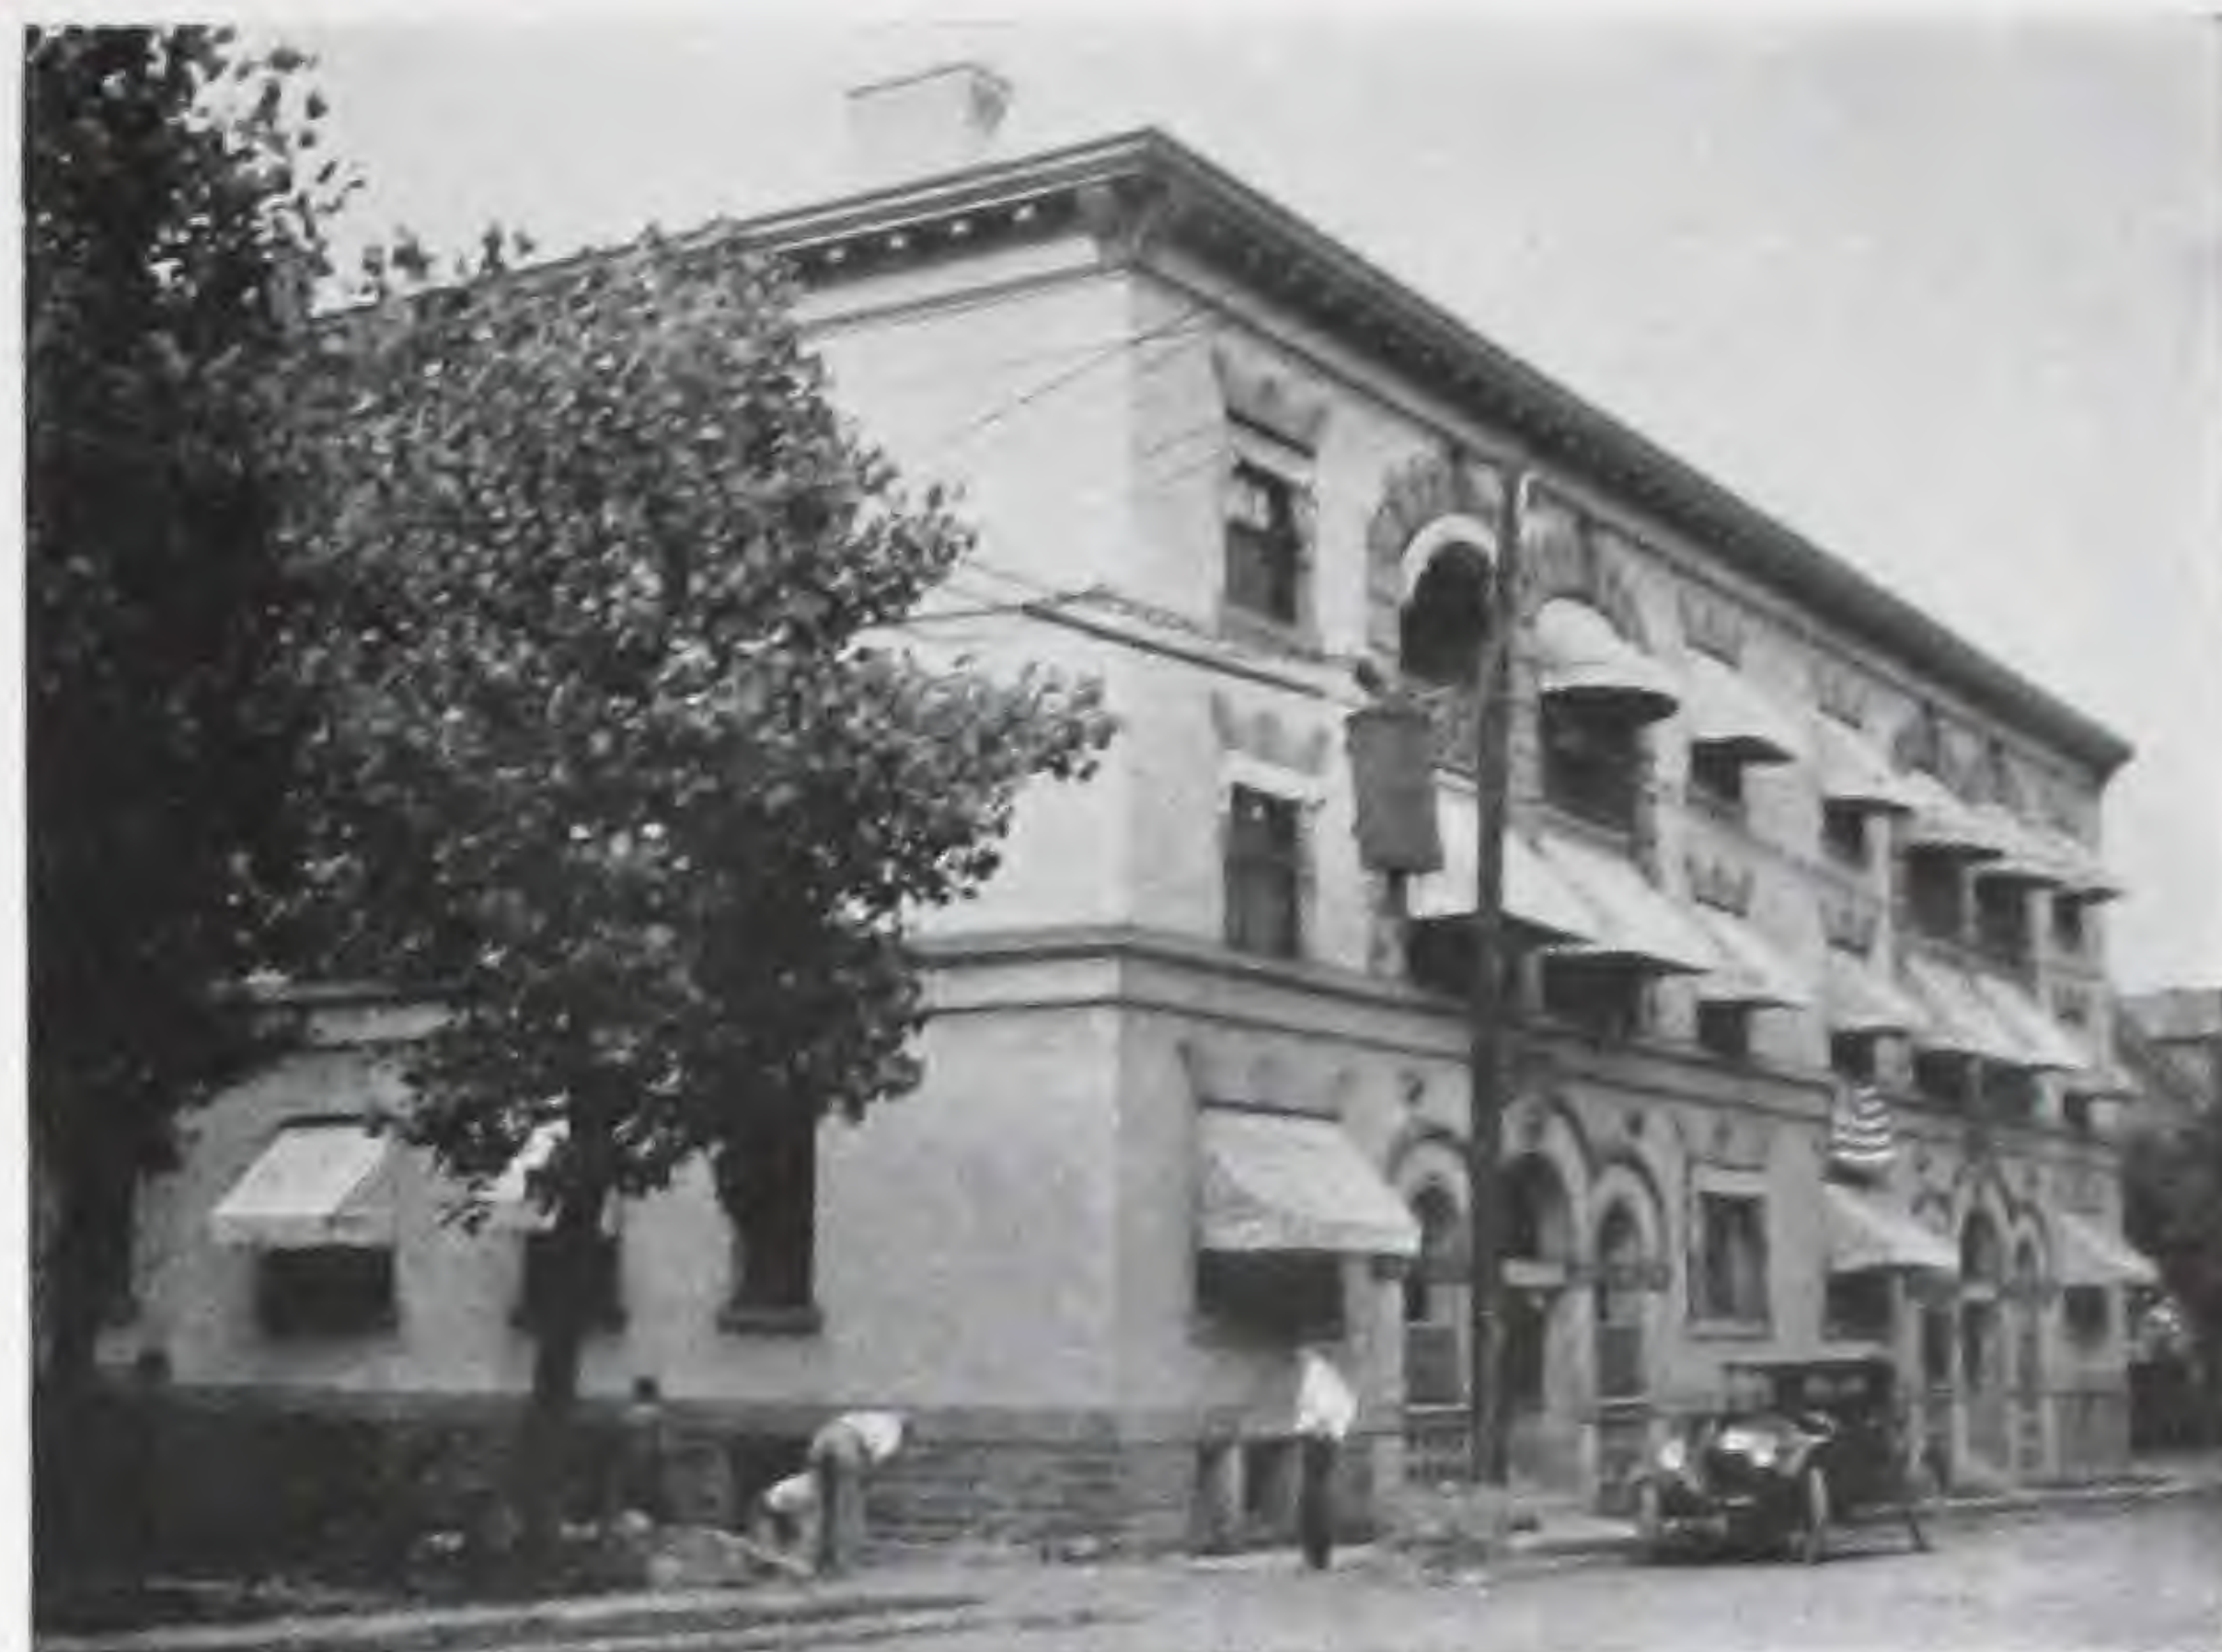
The Howe and Kent Apartments, erected 1907. The hot water mains are of brass and already show pitting. See records No. 16-17 on brass piping, page 18.

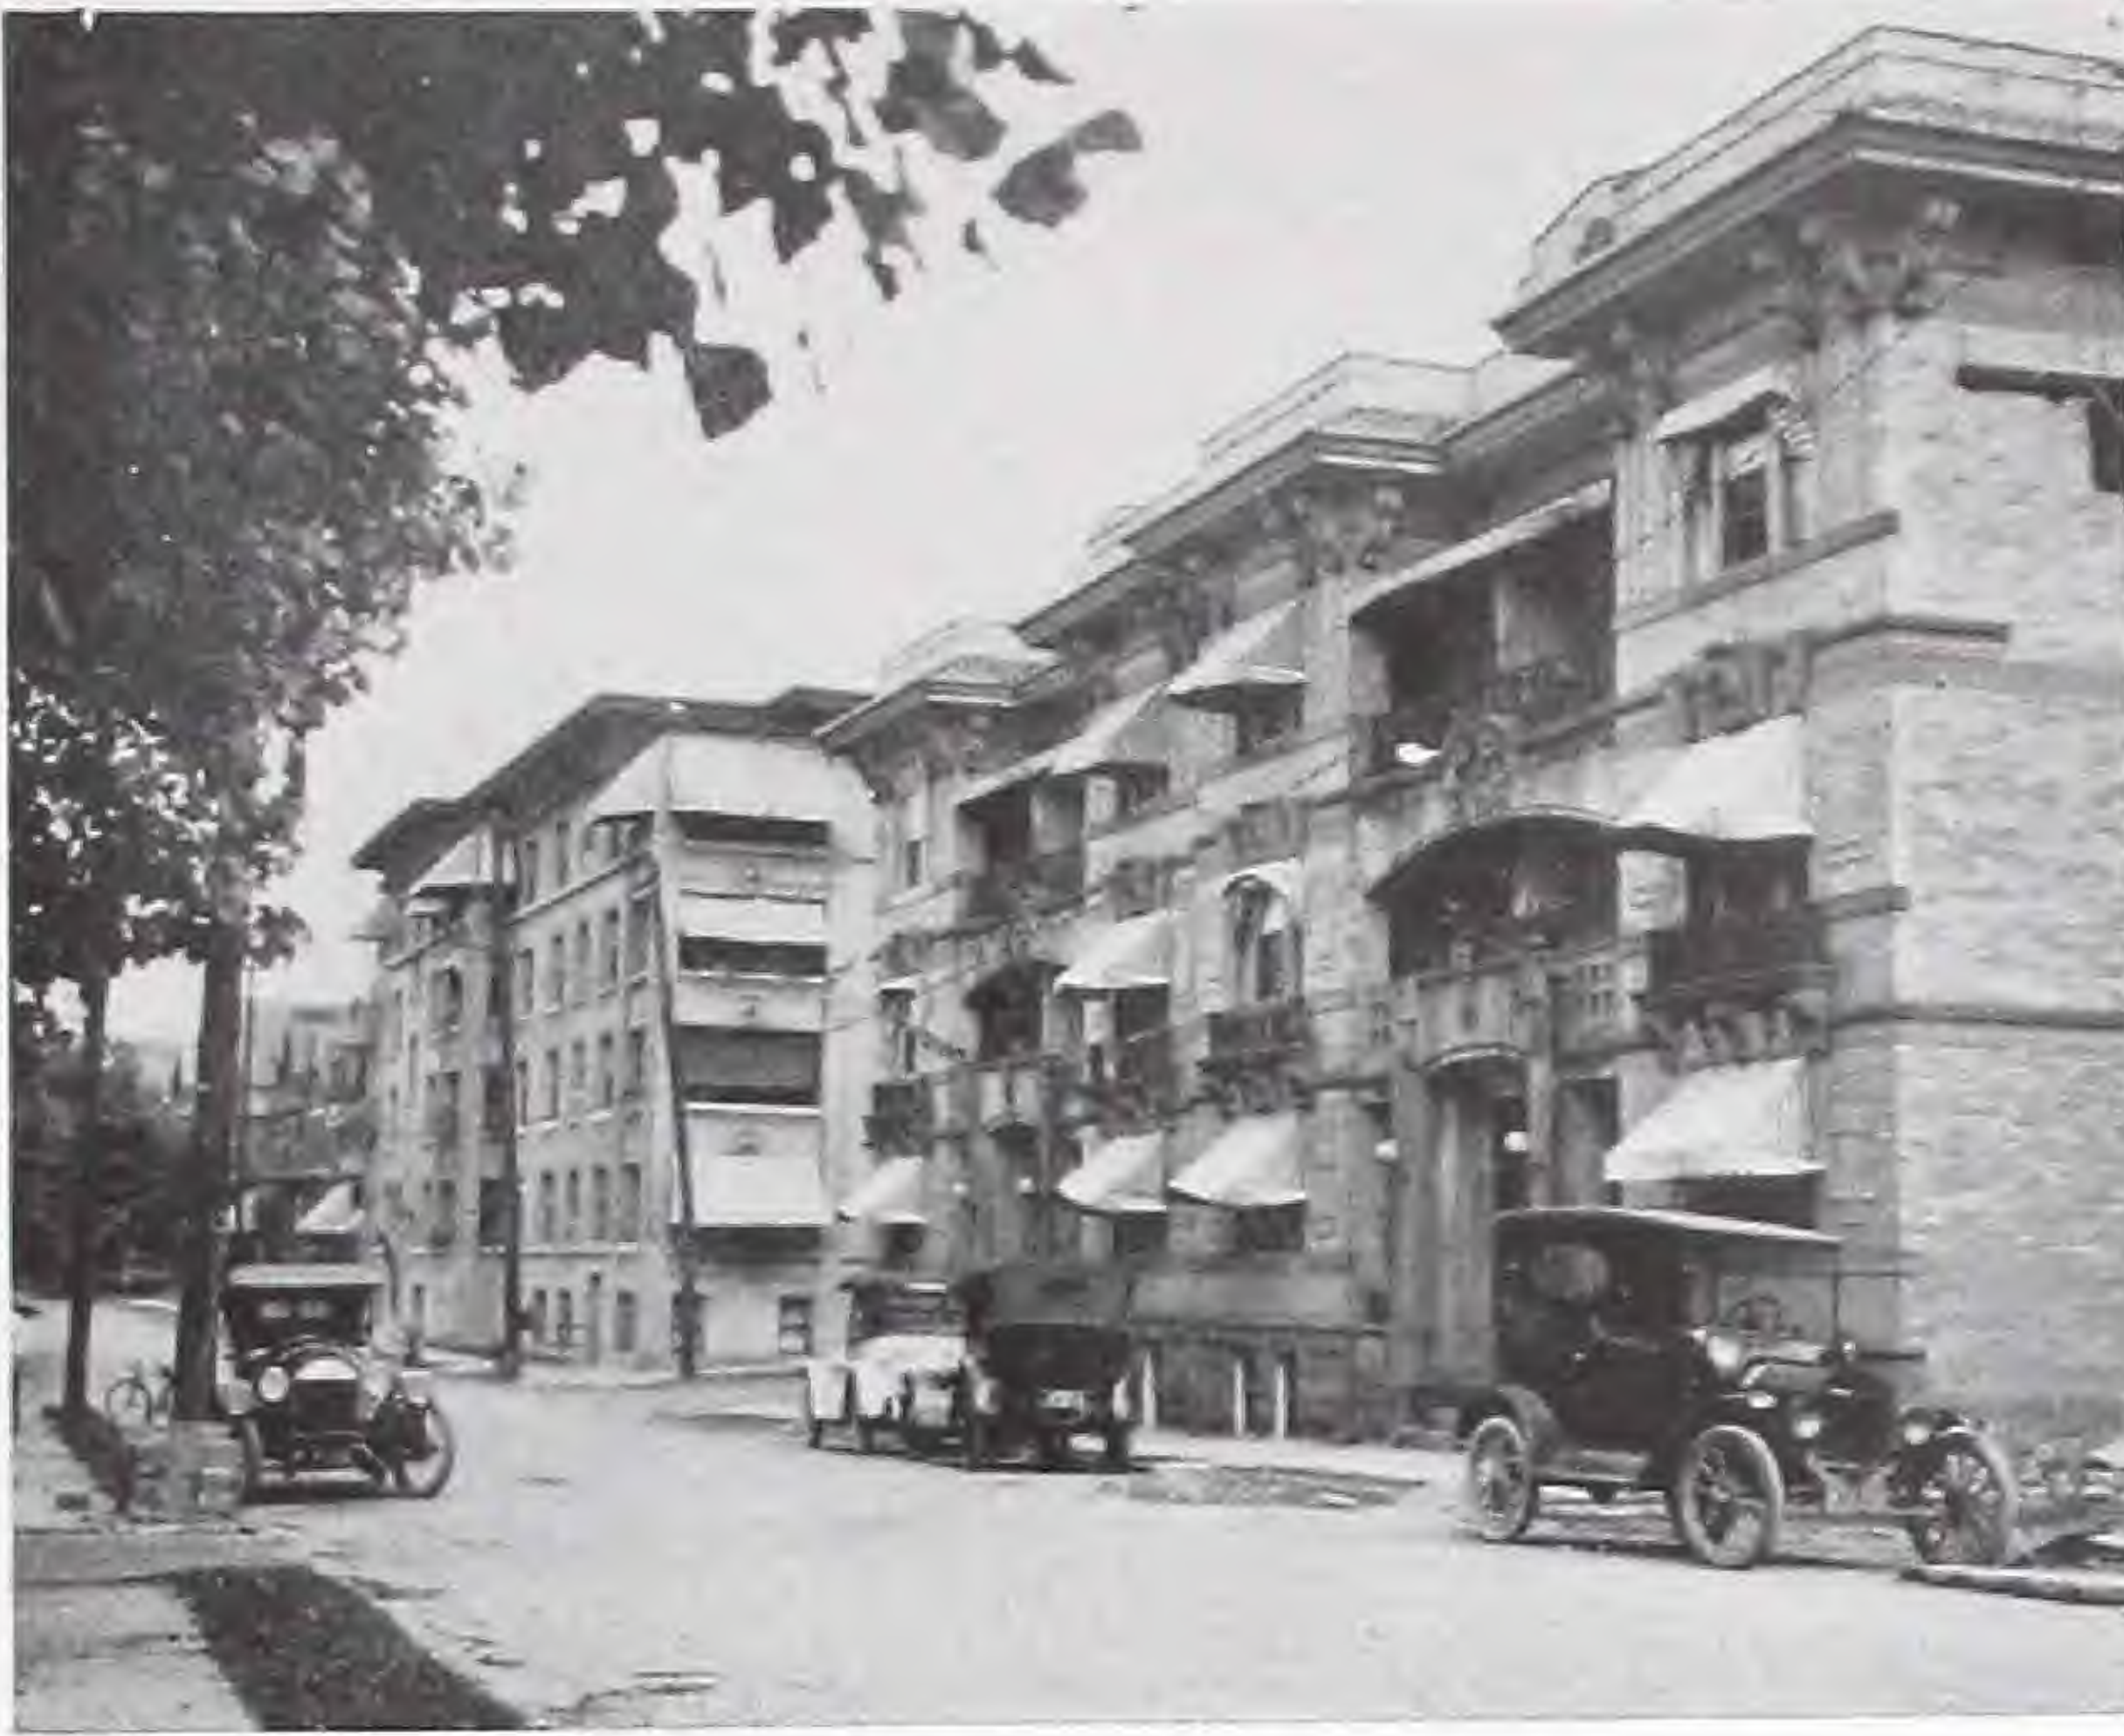
St. Regis, Chesapeake, and Chamberlin Apartments erected 1908. Equipped with steel pipe. Most of the hot water mains have already been replaced. See records Nos. 17, 18 and 19, page 14.

17. St. Regis Apts. Maryland and Howe.	18	1908	Cold water pipes too small and replaced in 1915. Hot water mains replaced 1915, account rust.	7 yrs.	7 yrs. Still good	See remarks
18-19. Chesapeake and Chamberlin Apts. Maryland and Howe.	12	1908	Gradually replacing hot water mains in basement.	s-10 yrs.	10 yrs. Still good	10 yrs. Still good

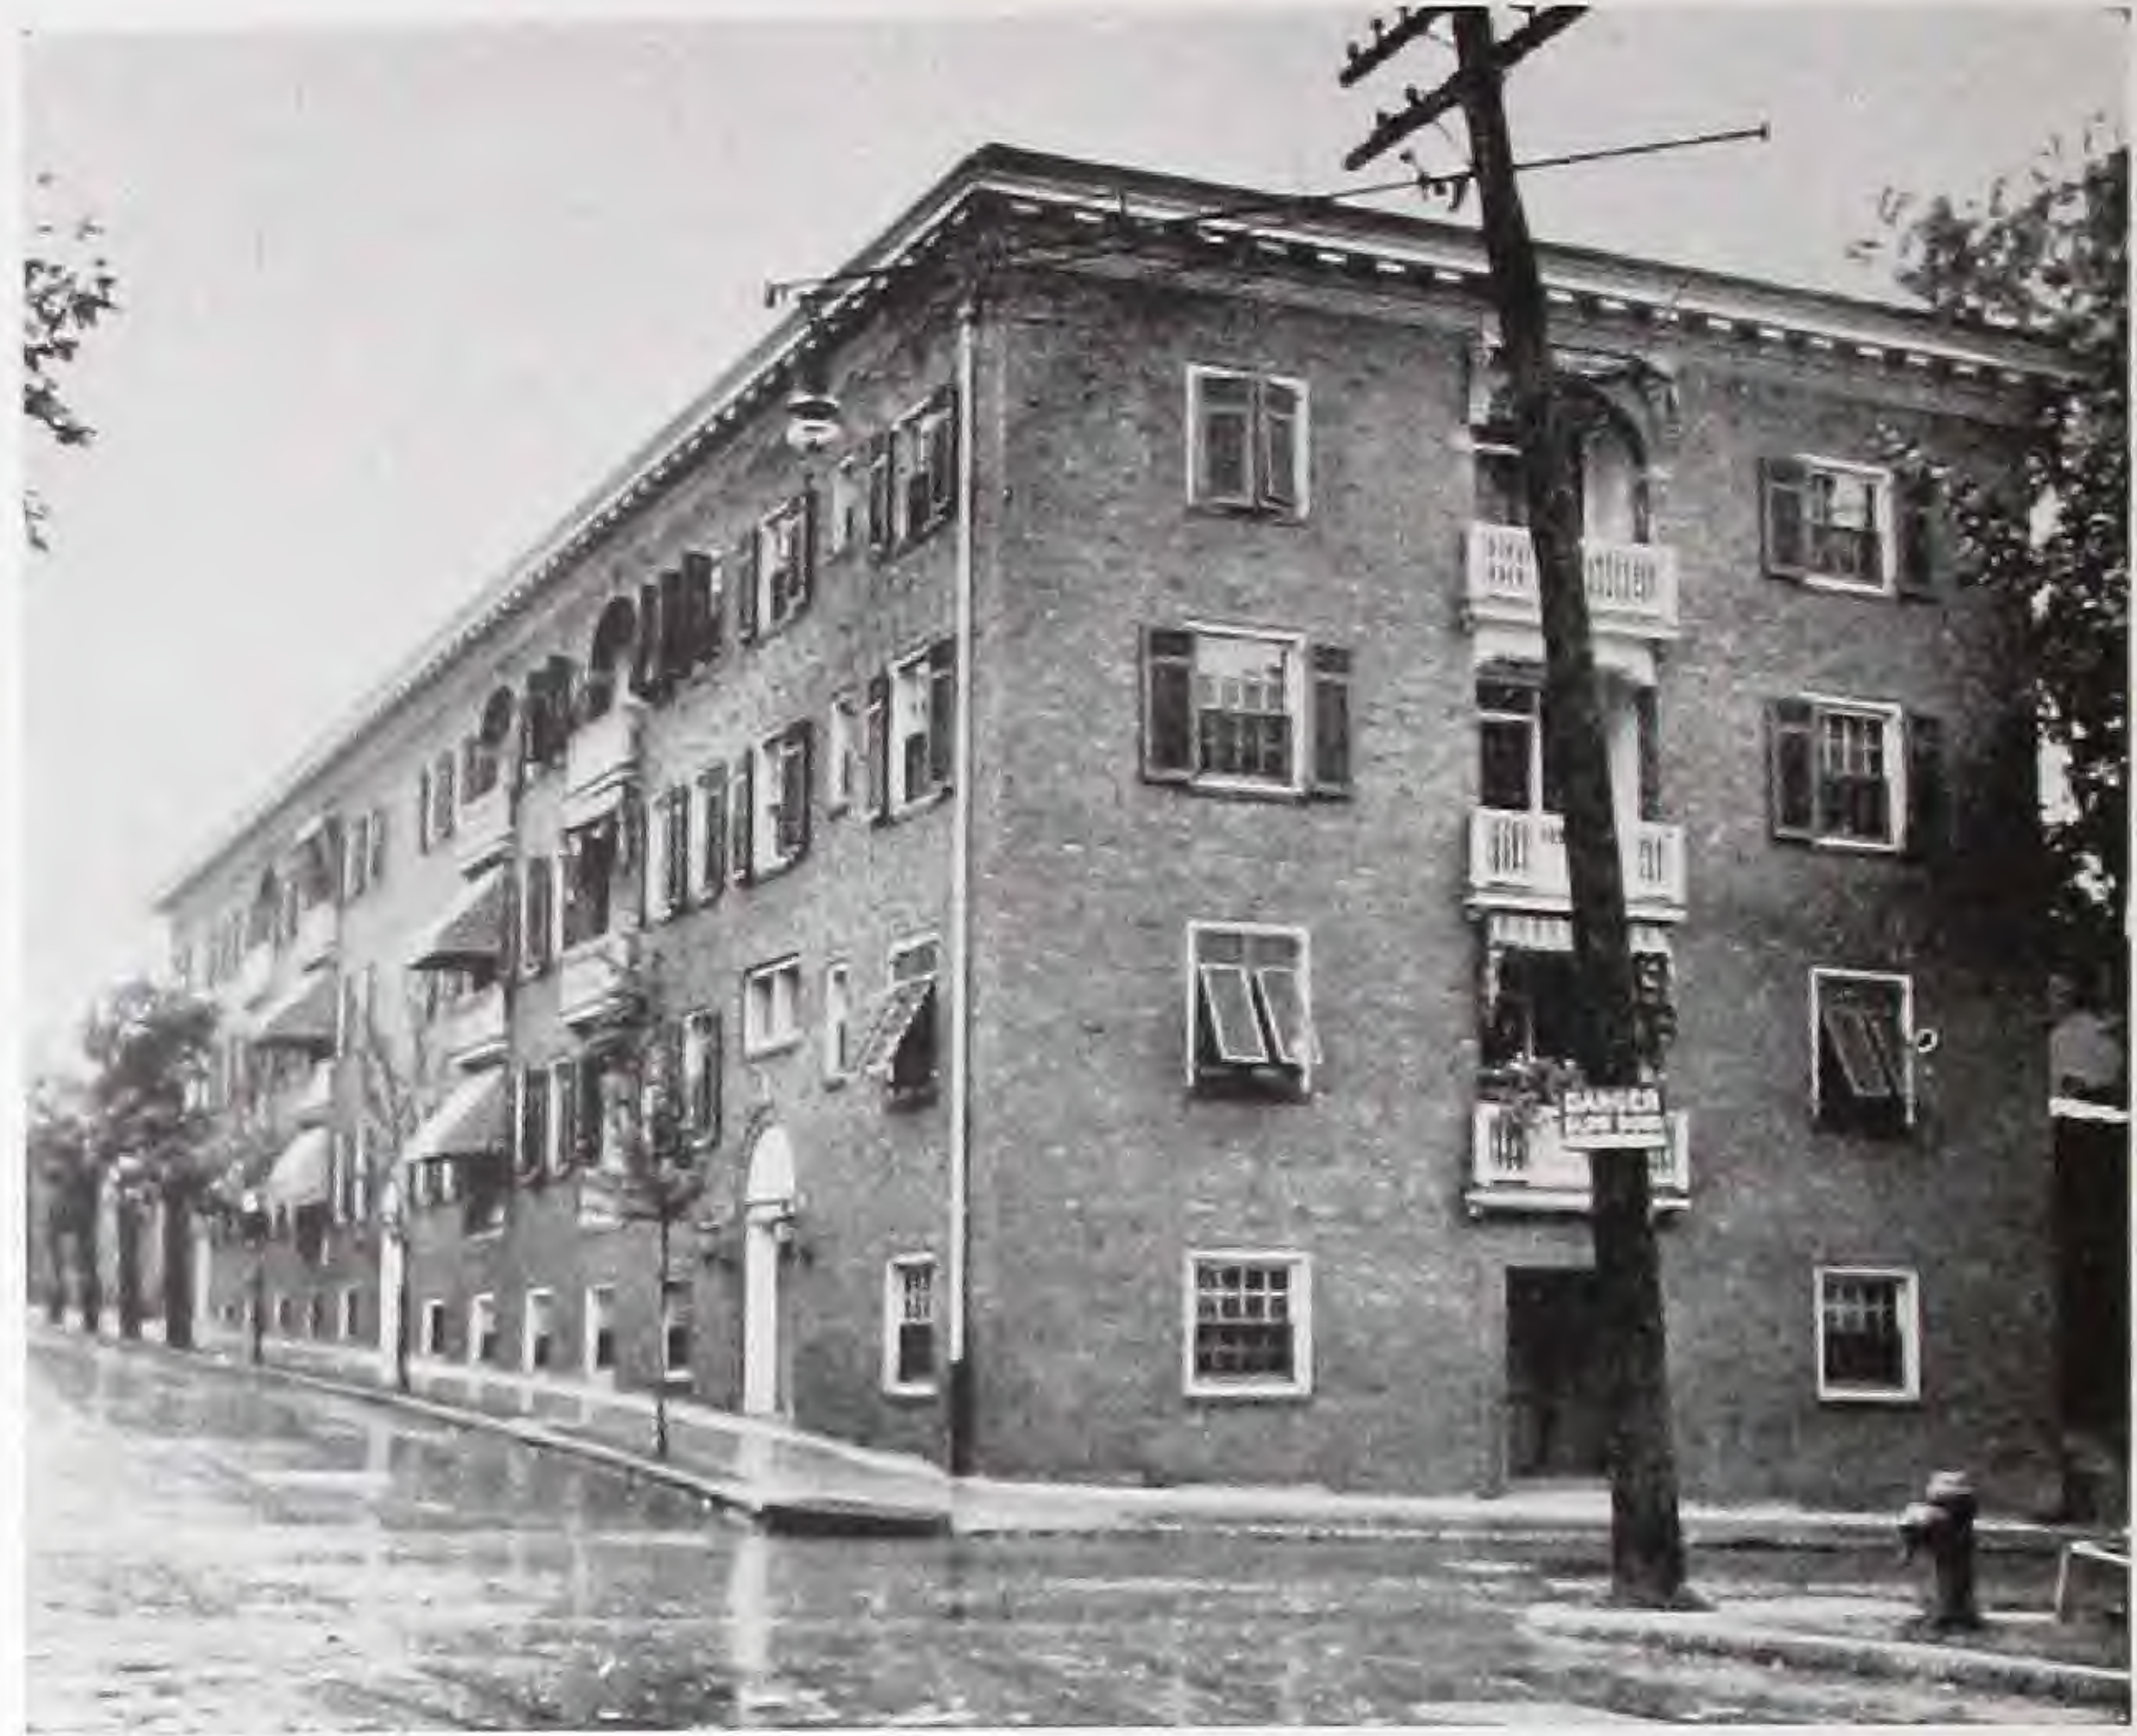
Negley Apartments, erected 1909. Hot water mains of steel, largely replaced between 1911 and 1914. Trouble with rusty water. See record No. 1, page 13.

Name and Location	No. of Apts.	Year Erected	Remarks	Hot Water		Cold Water Lines
				Mains	Risers	
1. Negley Apts. S. Negley and Elmer	18	1909	Hot water mains, largely replaced 1911-14. Rusty water.	4 yrs.	?	8 yrs. Still good
2. Berwin Apts.	6	1907	Gradual replacement of hot water mains since 1912. Rusty water.	s-7 yrs.	10 yrs. Still good	10 yrs. Still good
3. Elmont Apts.	6	1907				
4. Delwood Apts. Holden Ave.	6	1907				
5. Brayton Apts. 6. Crescent Apts. Negley Ave.	6 6	1907 1907	Gradual replacement of hot water mains since 1912. Some steel pipe used for replacement pitted through in one year.	s-7 yrs.	10 yrs. Still good	10 yrs. Still good
7. Darlton Apts. 8. Kingston Apts. Maryland and Elwood.	6 6	1907 1907	Instantaneous hot water heater. Entire system replaced 1915.	8 yrs.	8 yrs.	Still good

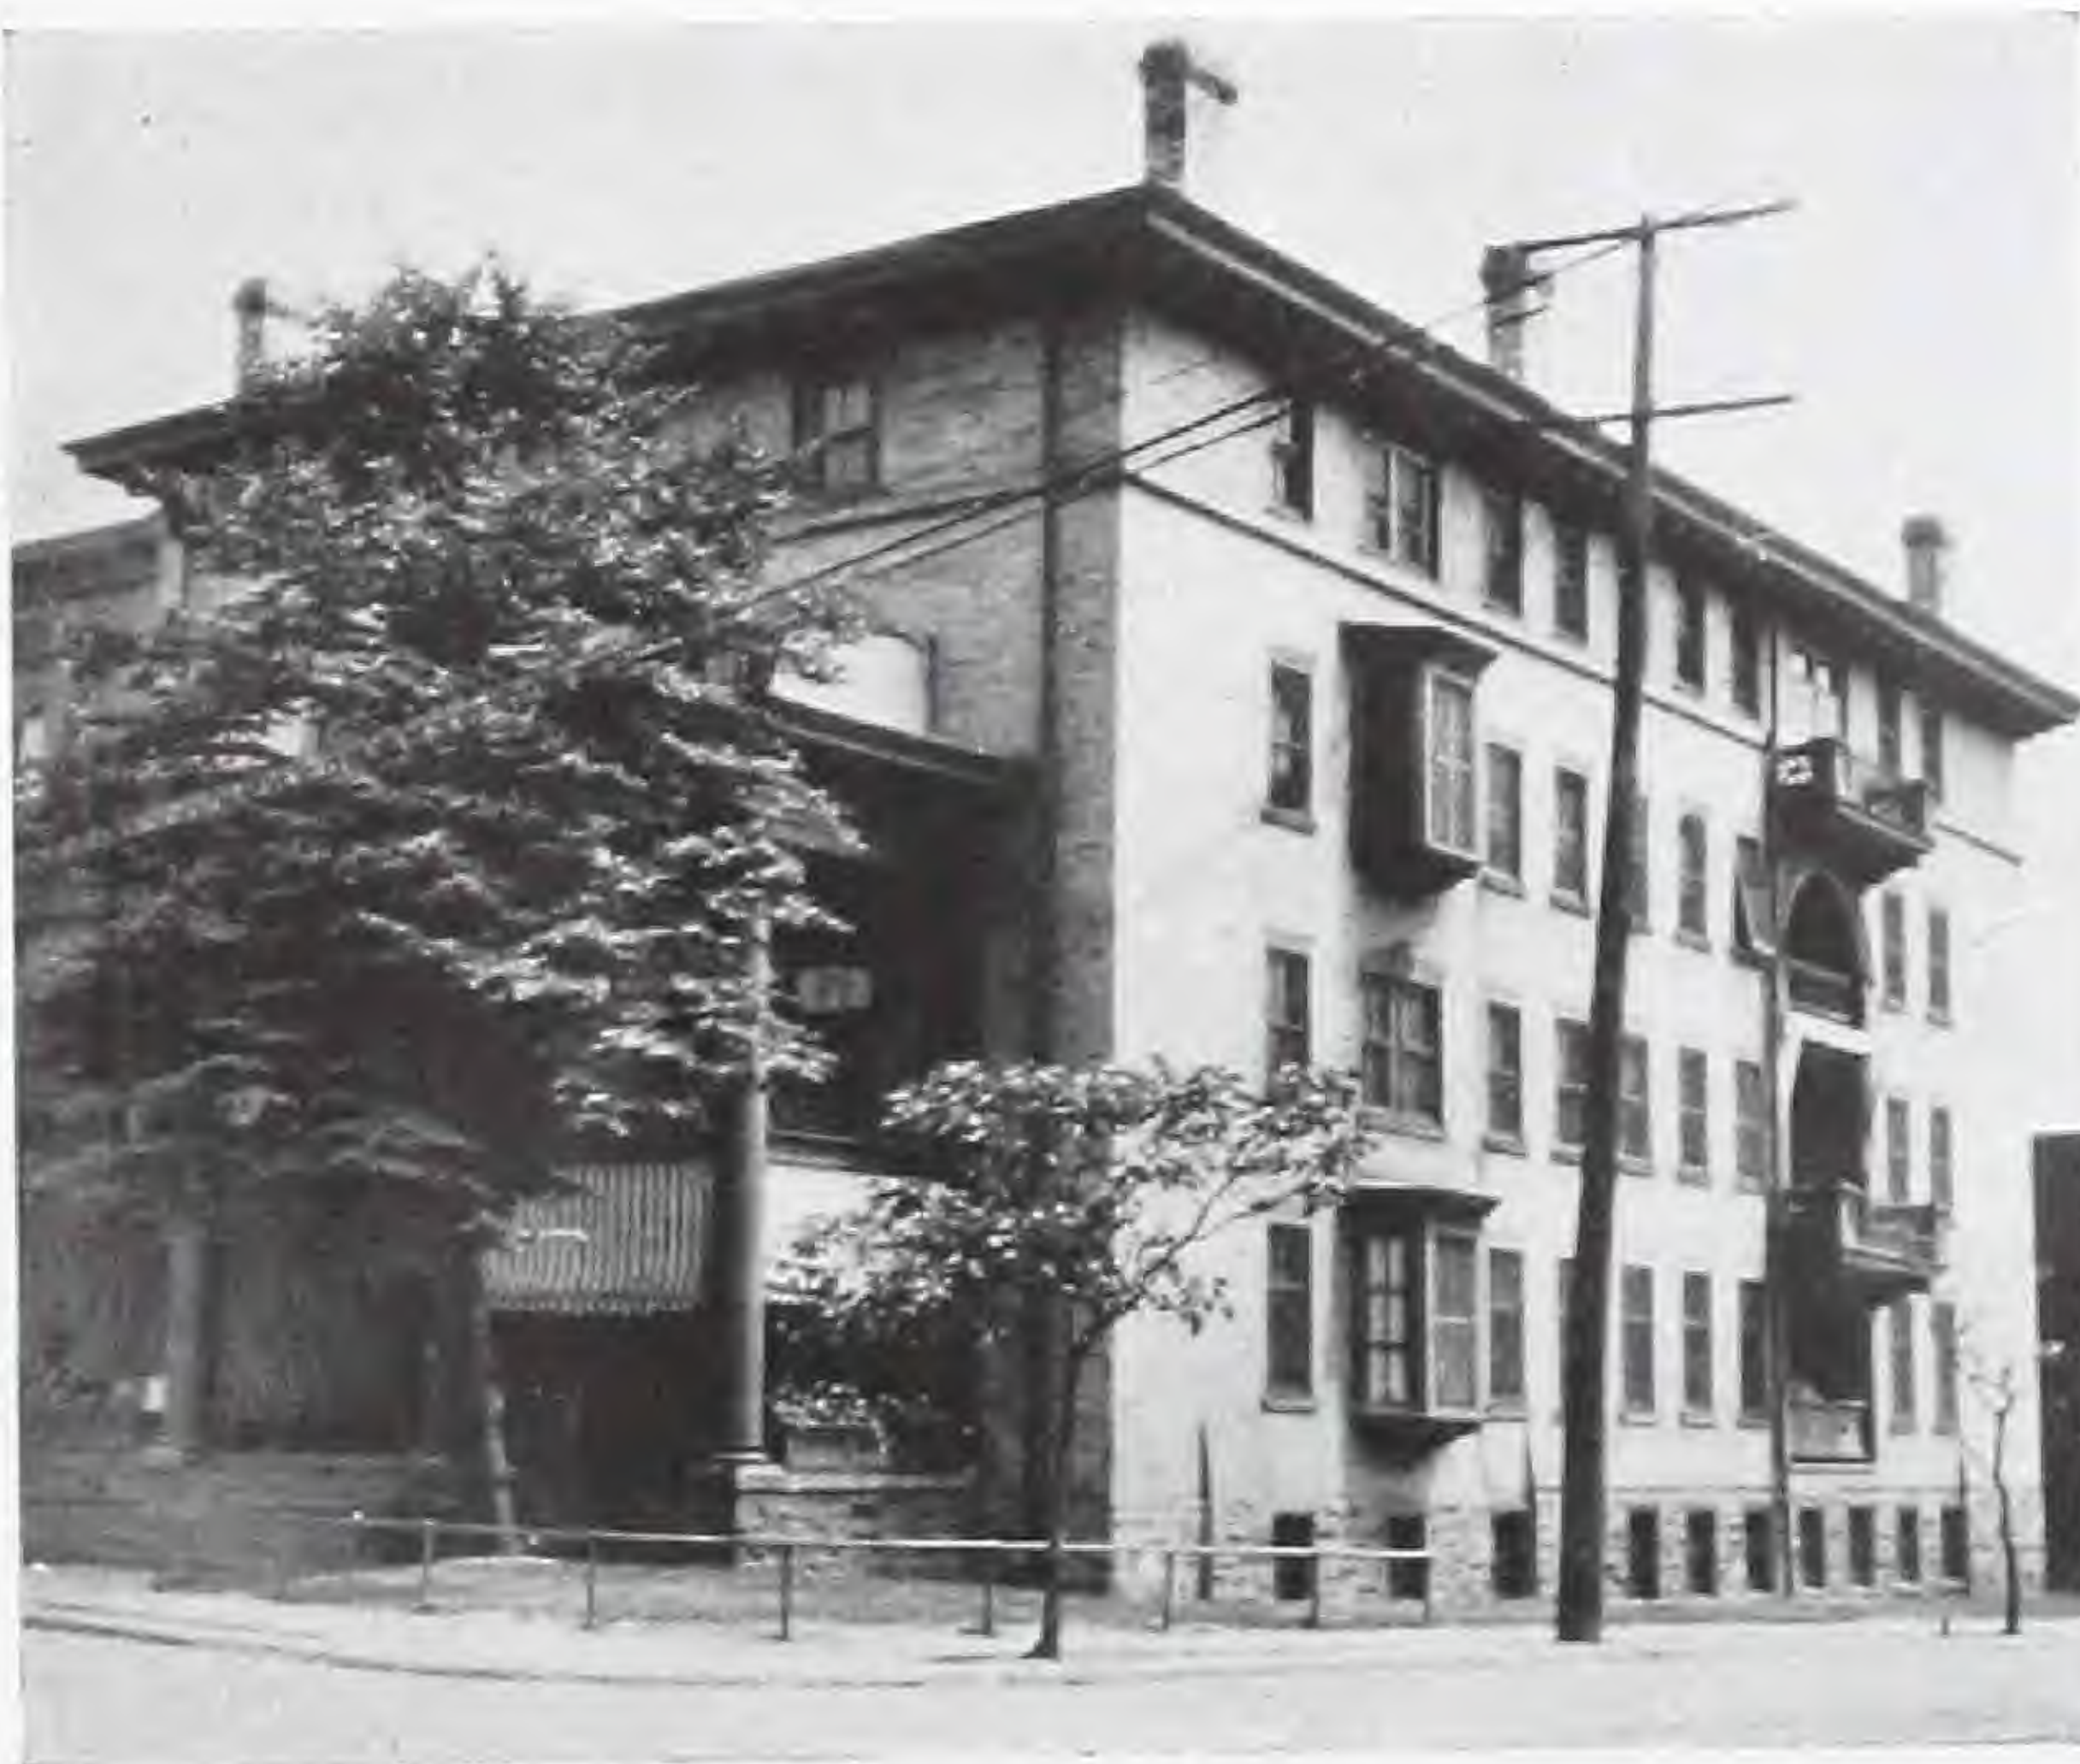
Kennett Apartments, erected 1902, equipped with brass pipe. Record No. 4, page 13. Typical of most apartments equipped with brass pipe, the hot water mains being badly corroded, after 10 to 15 years' service.
